## EC-100 Dirtguard S.M. Cool Waterproofing

Astec EC-100 DIRTGUARD S.M. is labeled with the Energy Star<sup>®</sup> logo and is a qualified Energy Star<sup>®</sup> product. EC-100 DIRTGUARD S.M. meets the Energy Star<sup>®</sup> specifications for cool roof coatings and strict energy efficient guidelines set by the (E.P.A.), Environmental Protection Agency.

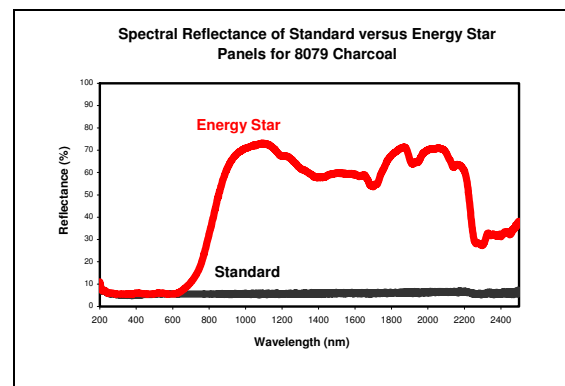
The comparative data represented on the graph below is actual Spectral results printed during tests conducted to ASTM E-903 on a Lambda 9000 Solar Reflectometer. The graph shows the difference in heat reflection between a standard Charcoal roofing paint and EC-100 Dirtguard S.M. Charcoal.
